# International Journal of Architecture and Planning

## Early Signs of Swamp Building Collapse: Failure of Wood Pillar Foundation

Nursyarif Agusniansyah<sup>1\*</sup>

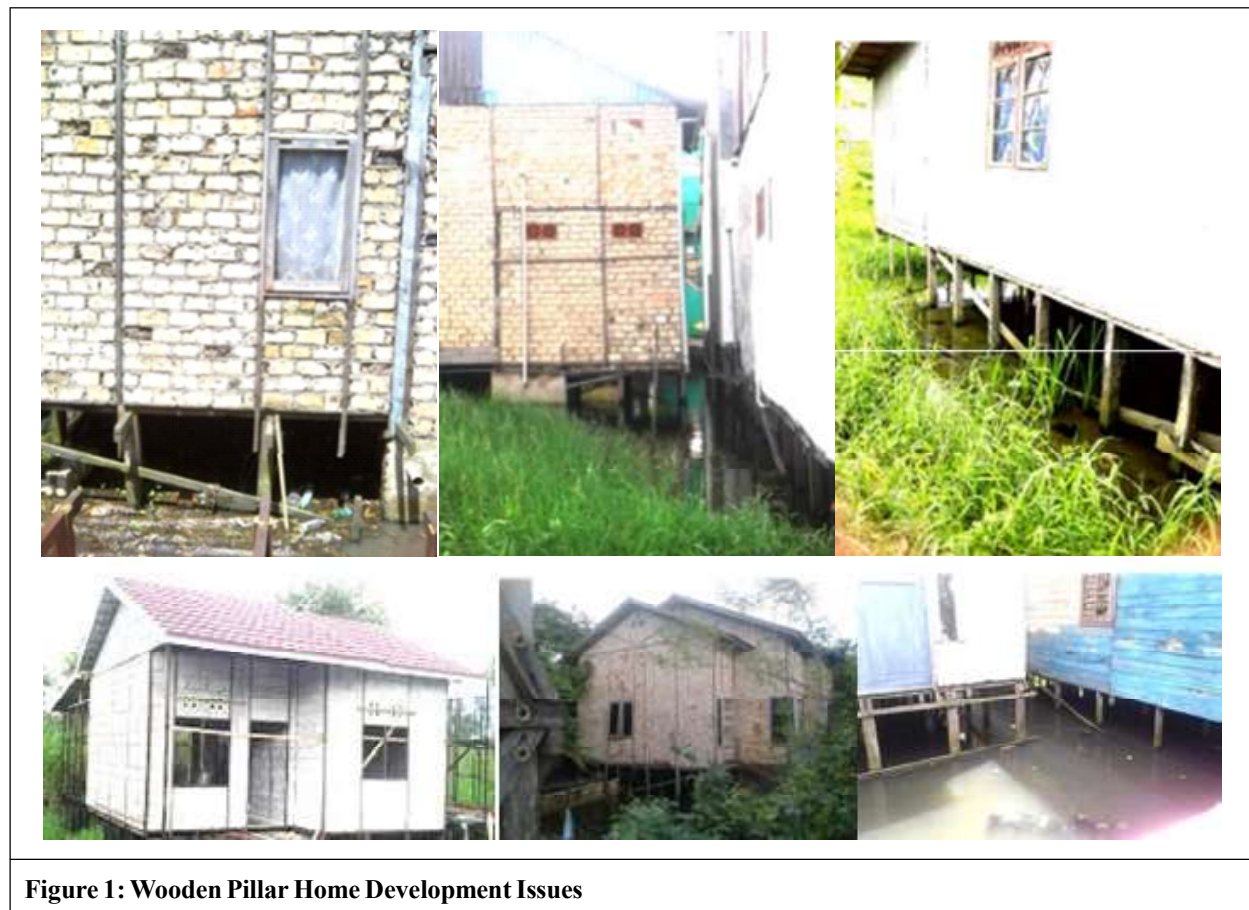
**Figure 1: Wooden Pillar Home Development Issues**

The problem of the wooden pillar houses is not free from the conditions of the wood pillar and the condition of the wet soil. The development of the semi-permanent building type (Figure 1) with the construction of bricks standing as the intercolumn filling of the wall pillars. Treated as permanent building finishing, plastered, then painted. Then the wooden floor material is mounted on ceramic.

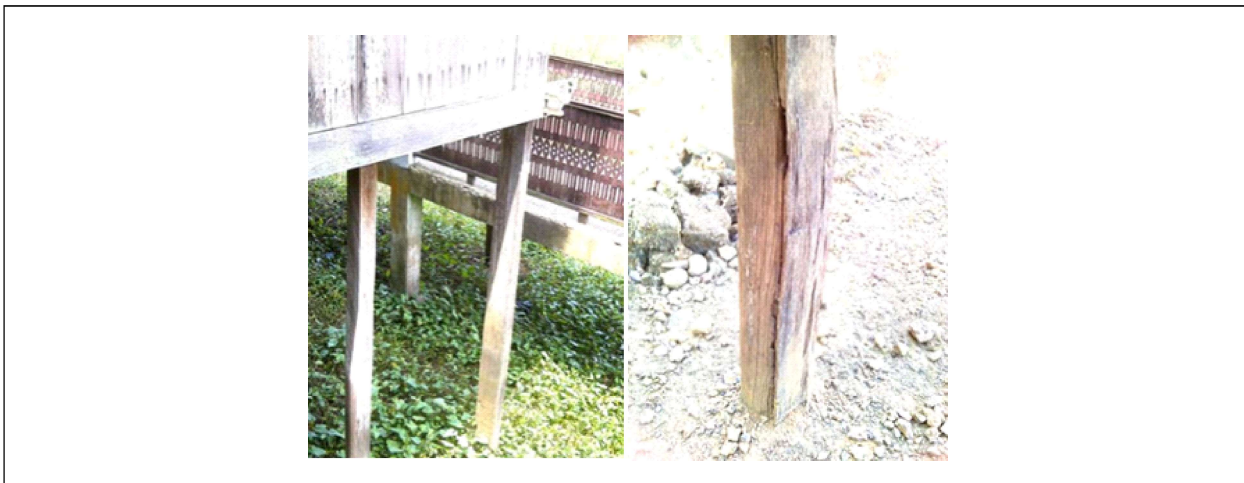
**Figure 2: Damage to Wooden Pillars**

The source of the problem of building houses mostly comes from the wooden pillars. The strength of a wooden pillar is equivalent to the quality of the wood, so the damage to the material also affects the condition of the construction. The damage to the pillar may be due to the inability to carry the load on it, and it is also often due to soil and weather conditions (Figure 2).

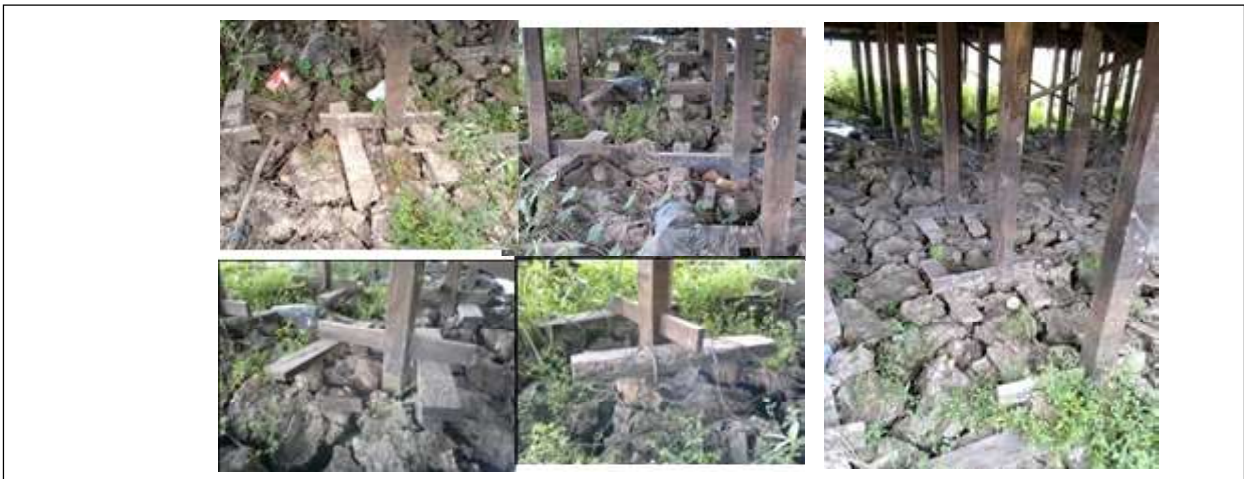
**Figure 3: ‘Sunduk’ Arrangement**

The wooden pillar is connected to the foundation part as an integrated part of a single unit. For the Banjarmasin area, use the support beam (‘kalang’) and the horizontal beam (‘sunduk’) seen in the Figures 3 and 4. After the hook, there’s a hook element that’s used to withstand the loads. In this element, there is usually a variation in the foundation and the presence of various other types of foundation.

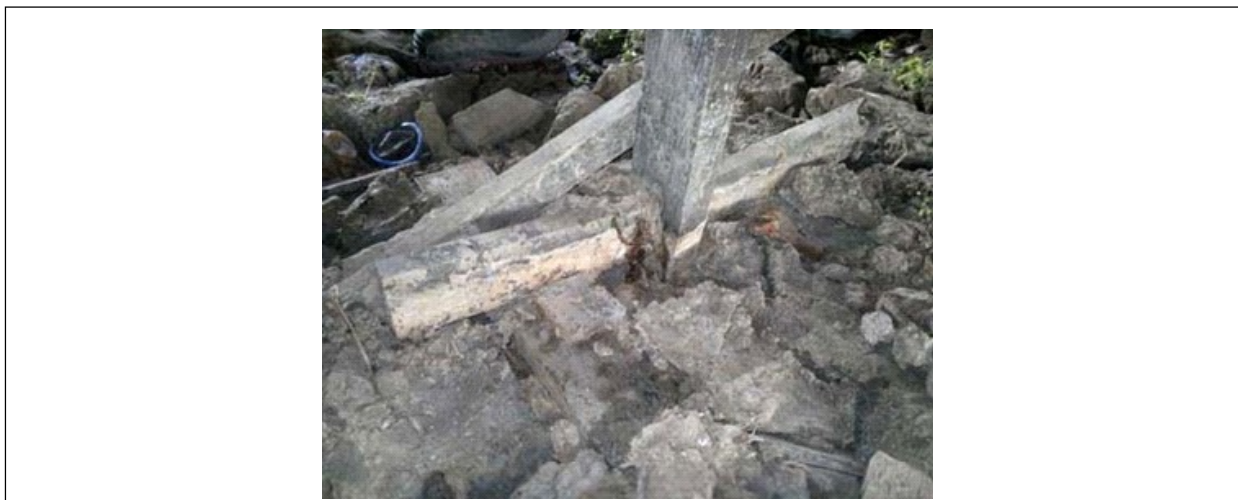
**Figure 5: Broken 'Sunduk'**

Broken 'sunduk' from the picture, you can see the condition of the bottom of this wooden pillar. It appears that the mounting of the cuffs and braces when under the surface of the water becomes unclear by adjusting the position of the scissors. There is a field finding that there is a state of wood damage with the presence of a broken crown (Figure 5). This could be the cause of the falling floor in the house anyway. Because of the quality conditions of the cane, often the remaining pieces of wood, small and have a wooden eye, resulting in a broken cane. However, because the position of these building elements is below the surface of the water, this often leads to invisibility. Photo taken from the field survey with the conditions of the dry land area, so it can be clearly seen this situation.

Improving 'sunduk' in wood foundations involves using durable materials, reinforcing the base, enhancing structural connections, and considering hybrid designs. By integrating modern construction techniques with traditional methods, it can create a stronger, more durable 'sunduk' that is resilient to moisture and environmental challenges. Regular maintenance and inspection are also essential to ensuring the structure's longevity. It is recommended to find a hybrid wood design with concrete material to improve wood foundation stability.

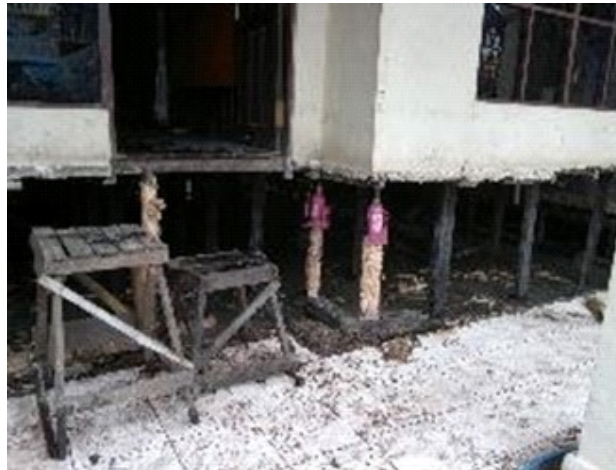
**Figure 6: Scratching House Pillars**

Other field finds include the activity of replacing wooden pillars with a way of crushing houses (Figure 6). It's done because the floor position of the house needs to be raised.

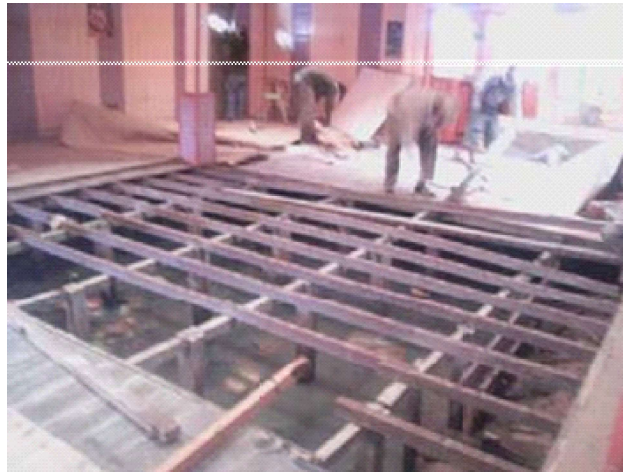
**Figure 7: Falling And Folding Floor**

Damage to the wooden pillar element can cause falling and bending of the floor (Figure 7). The construction of the floor is visible with a 50 cm floor beam, and continues to be lifted by rows of wooden columns. The characteristic of the fall of the foundation and the bending of the floor of the building is the presence of the ceramic floor covering that is broken and raised like in the Figure 8.

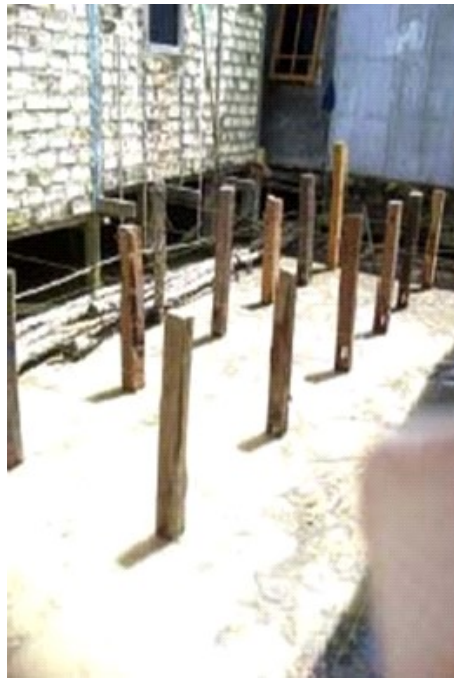
**Figure 9: Horizontal Home Extension**

It was found that the development of the wooden pillar house was done by renovating horizontally to expand the space of the house with the addition of space (Figure 9). A wooden pillar is added to an empty plot.

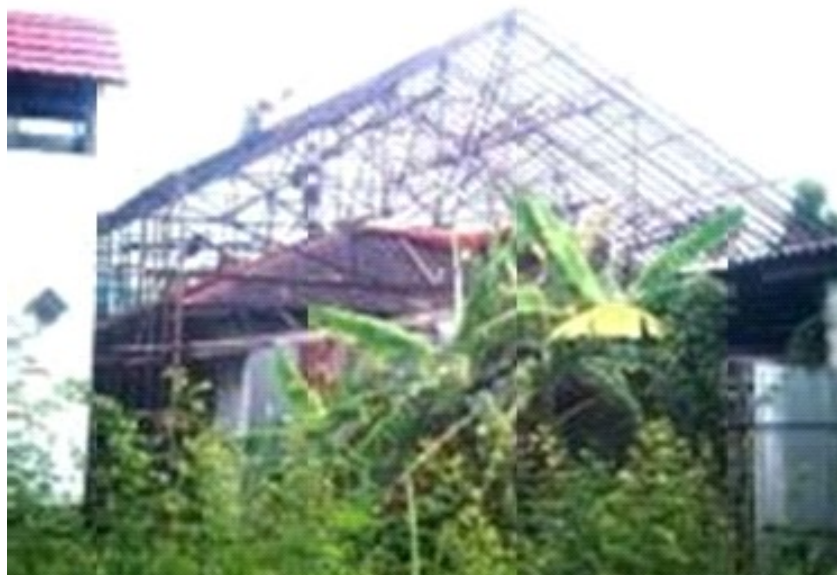
**Figure 10: Vertical Renovation**

The most common thing about building houses with wooden frame structures is the repair or renovation of houses vertically (Figure 10). By demolishing the roof of the building and making it into a flat-scale house, the building burden increases. Even with the consideration of replacing the top material of the building with an even lighter material, this will increase the burden on the foundation.

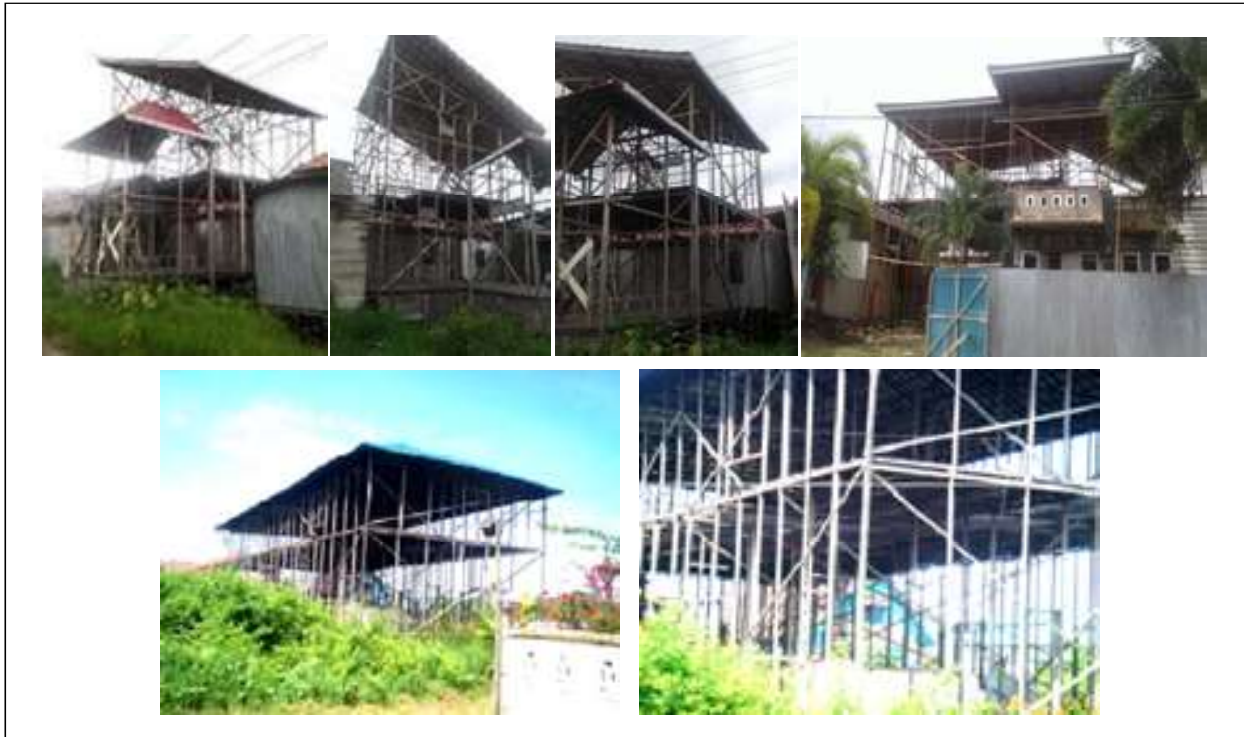
**Figure 11: 2 Story Wood House Building**

Besides, make the building of a house directly 2 (two) floors (Figure 11) and frequently done. But the foundations of the buildings used seemed to remain the same as the foundation conditions of the one-story buildings. Because the construction system and the material remained a row of wooden pillars on the bottom and a wooden frame on the building. Both of these cases actually require reinforcement of a wooden pillar to accept the added building burden.

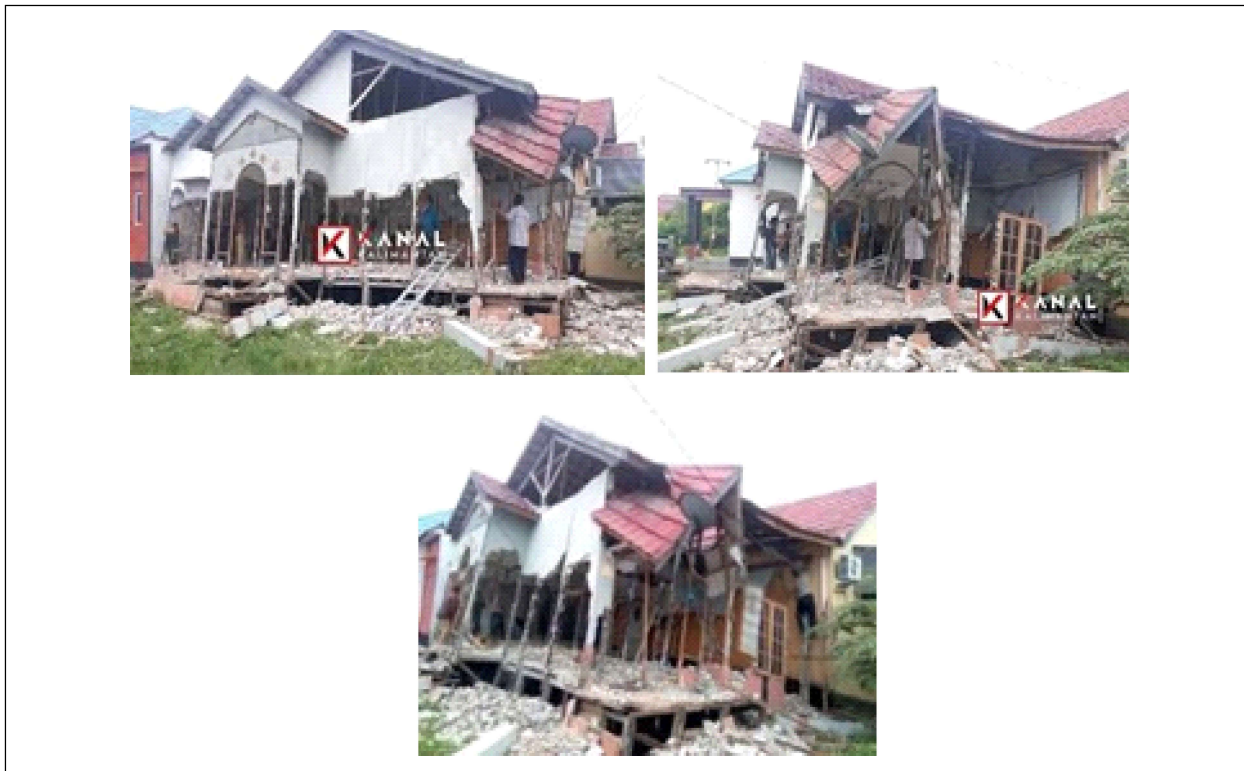
**Figure 12: Tilted House Building**

With more severe damage to the wooden pillars, there could have been some cases of house buildings that were not only bent but even collapsed (Figures 12 and 13). It is often said that this occurred because of the failure of the foundation of the house to follow its pillars. Errors in the selection of foundations, the lack of strength of the foundations and poles to carry the heavy building burden, or the depression and inexperience of the construction workers are often accused of being the cause. The wooden pillar is still involved.
